### Scope of Document:

This document provides detailed procedures for replacing all firmware in all Qualstar TLS models. Refer to Table 1 for a list of the applicable boards (PCBA's – Printed Circuit Board Assemblies), firmware part numbers and the libraries in which they are used. All firmware is contained in *dual-inline* integrated circuits which are easily changed without the need for special tools.

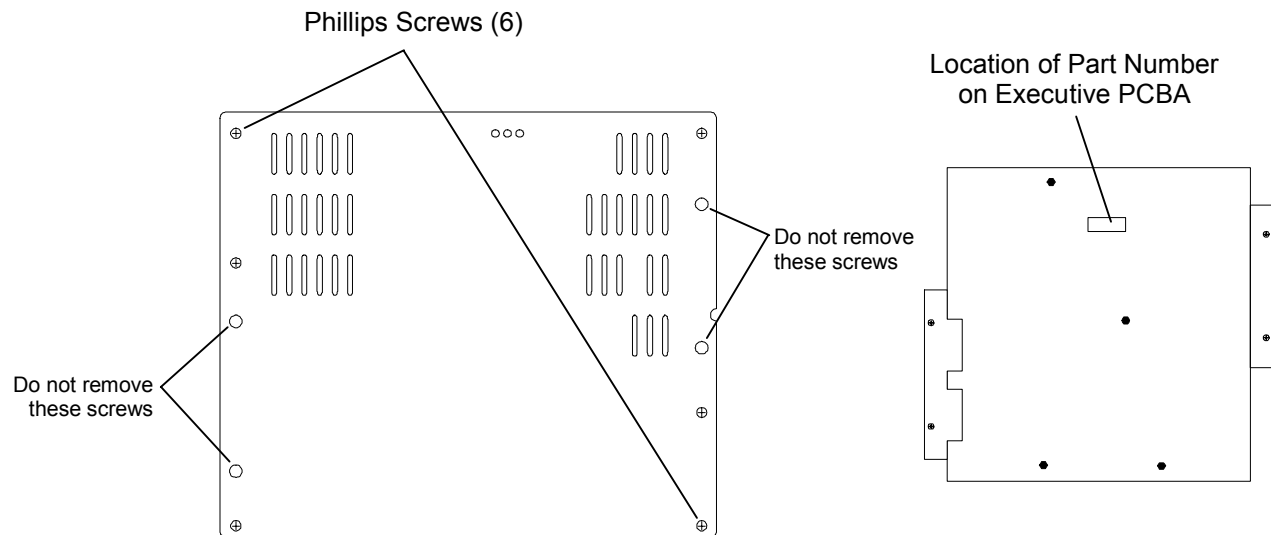
**Figure 1 Rear Service Panel and PCBA Part Number Location**

1. All TLS-2000 models utilize the Executive I PCBA (P/N 500657-01-0)
2. For all other models, the Executive PCBAs type can be determined by removing the service panel from the rear of the library and reading the part number printed on the Executive PCBA. There are two such panels on the TLS-412xxx, 68xxx and 88xxx models. Follow steps 3 through 5.
3. Remove power from the TLS: first turn the power switch off and then remove the power cord.
4. Remove the six Phillips screws securing the service panel on the rear of the library – refer to Figure 1 below. Care must be taken to not remove the four screws securing the heatsink panels.

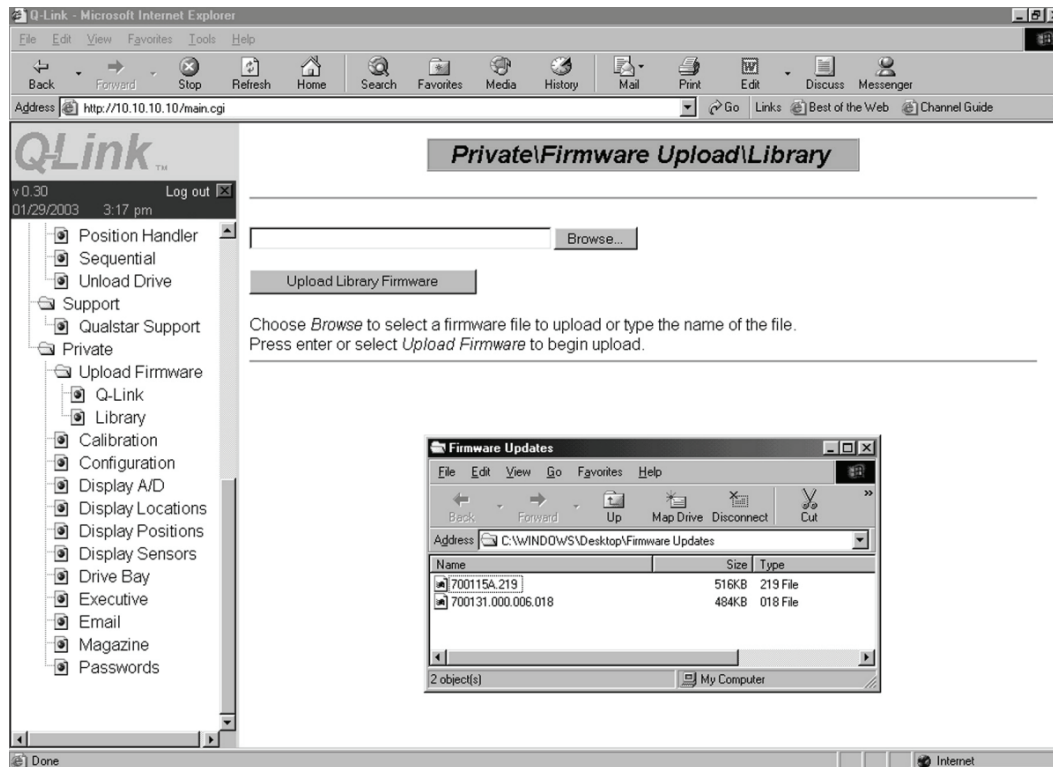
**Figure 2 Sample of the Library Firmware Upload Screen**

- Access the firmware file by either clicking on the Browse button or typing the file path to the firmware file.

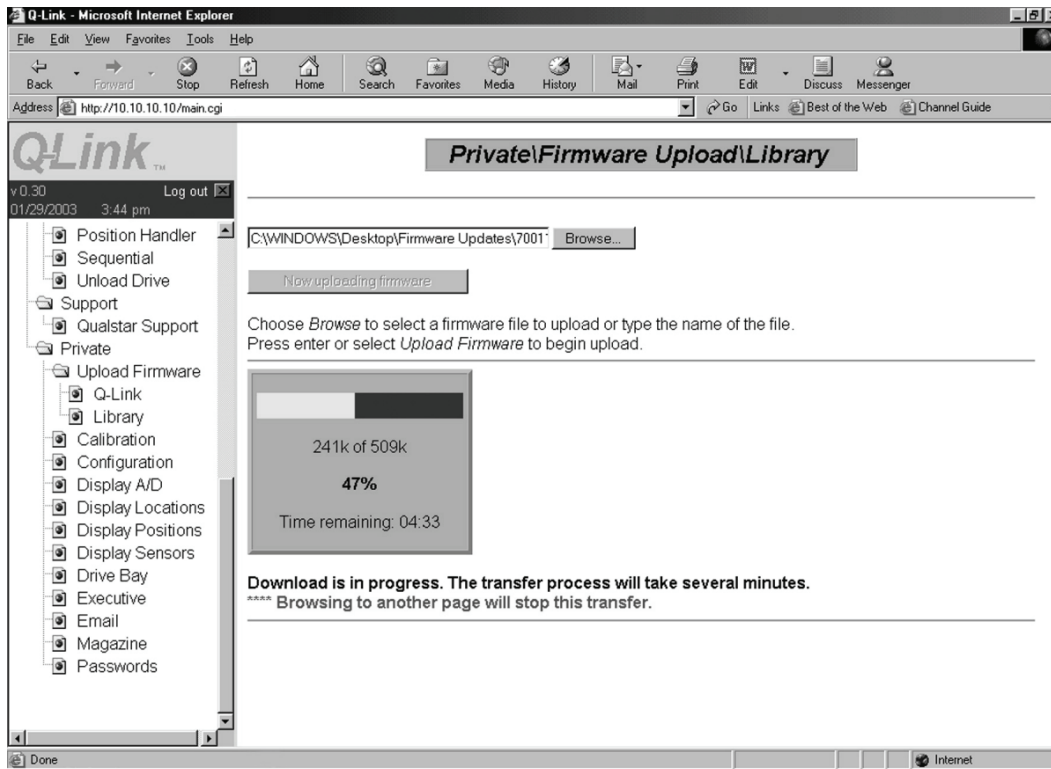
**Figure 3 Sample of the Library Firmware Upload Progress Screen**

2. Press the enter key or click on the Upload Firmware button to begin the uploading process.
3. Note that after the upload begins browsing to another page will stop the firmware uploading process.
4. Two different screens will appear as the uploading process proceeds. See Figure 3 and Figure 4.

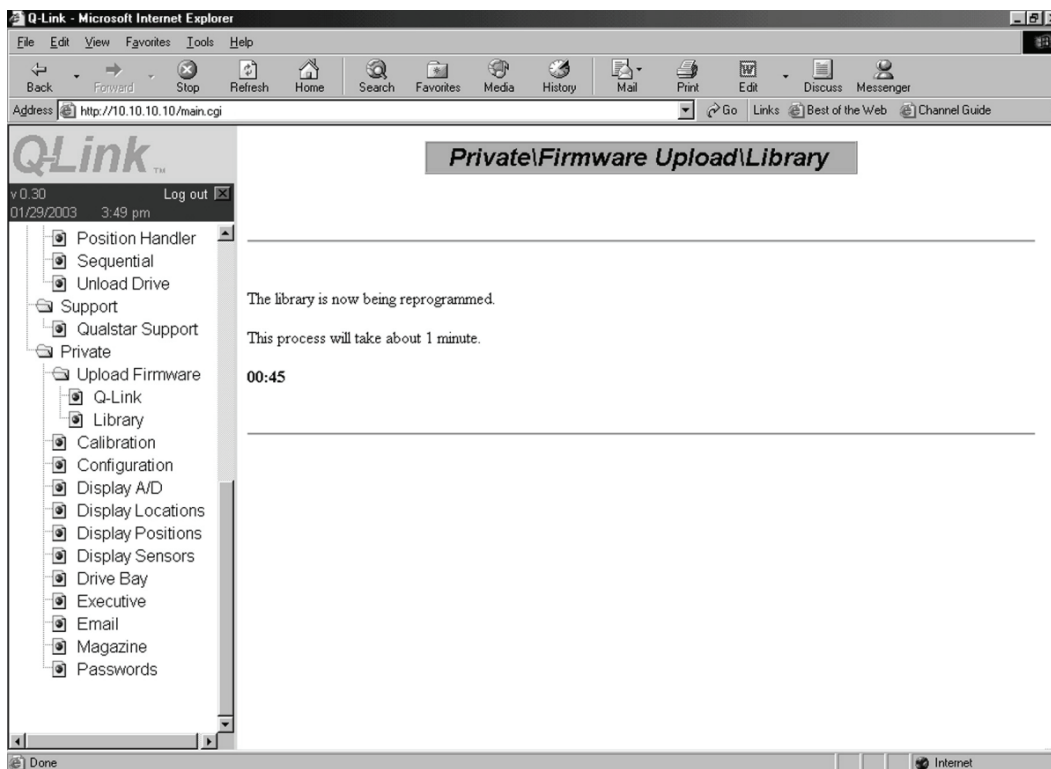
**Figure 4 Sample of the Library Firmware Reprogramming Progress Screen**

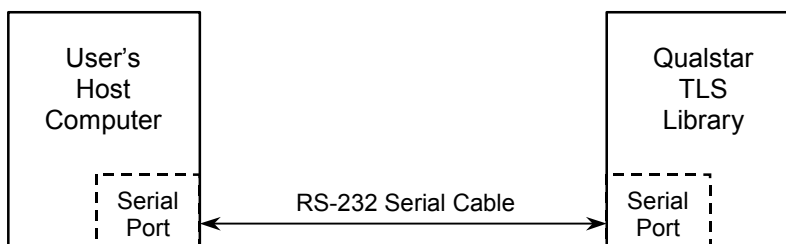
**Figure 6 Host Computer Connected to TLS**

The user's host computer and the TLS are connected together using a NULL modem serial cable. This cable must have female DB-9 connectors at each end and wiring such that pins 2 and 3 are crossed over and pins 5 are connected to each other at both ends. See Table 5.

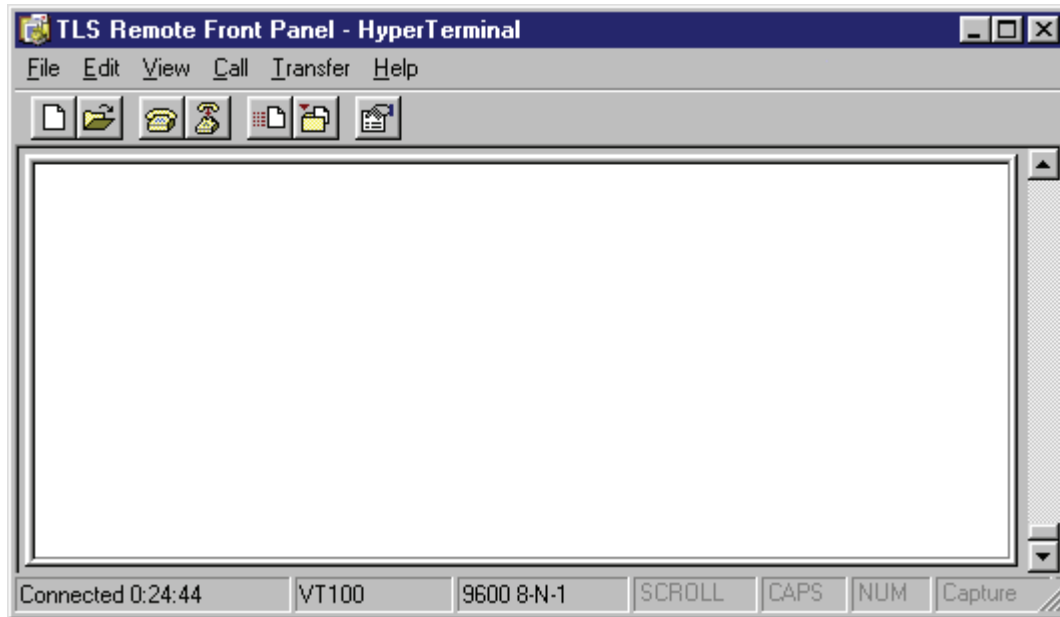
**Figure 7 TLS Remote Front Panel Program Displayed in HyperTerminal**

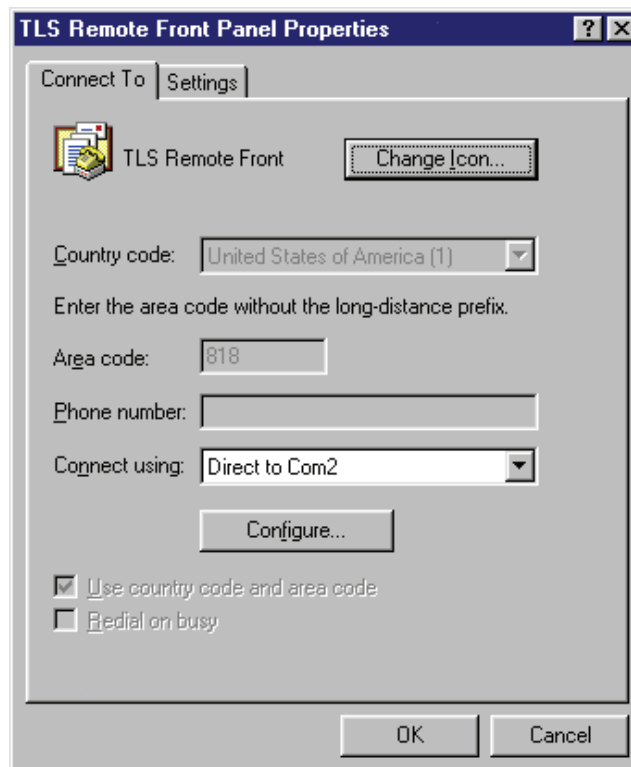
**Figure 8 Properties Screen**

Use the **File\Properties** menu selection to configure the application for direct communications. Select the appropriate communications port. See Figure 8.

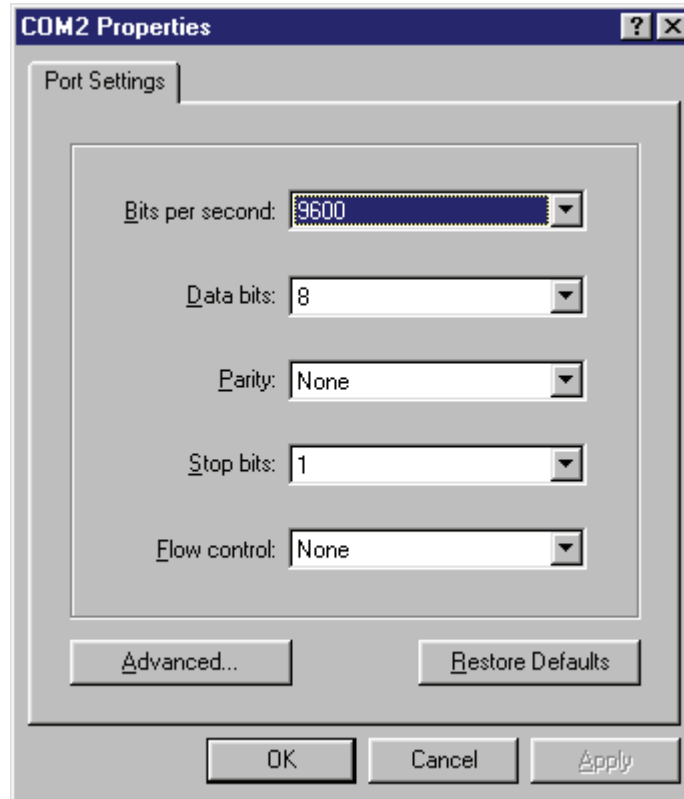
**Figure 9 Configure Screen Under the Properties Menu**

Select the **Configure** button to set the communications parameters for a baud-rate of 9600, with 8 data bits, no parity, one stop bit and no flow control. See Figure 9.

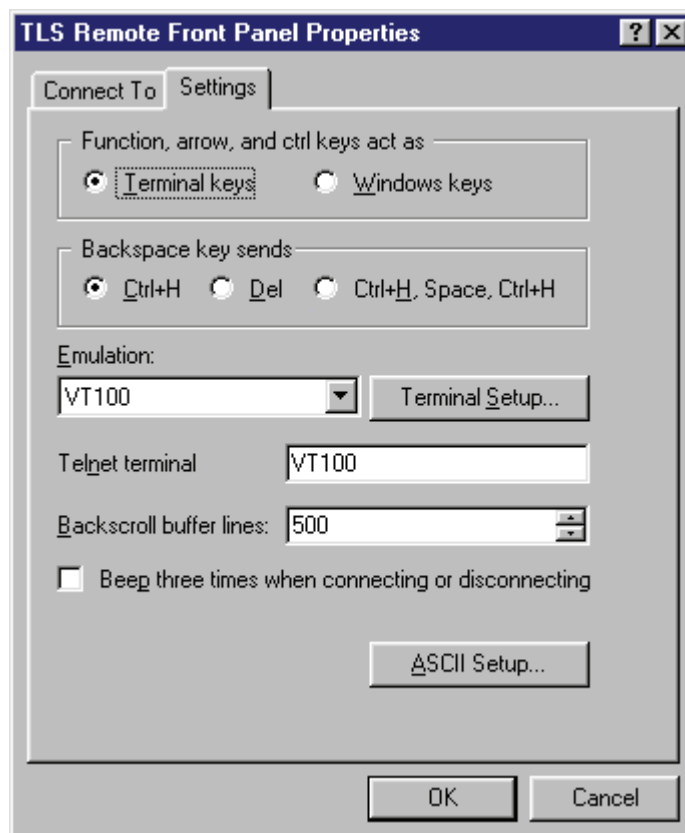
**Figure 10 Settings Screen Under the Properties Menu**

Use the **File\Properties Settings** dialog tab to configure the application for VT100 terminal emulation.

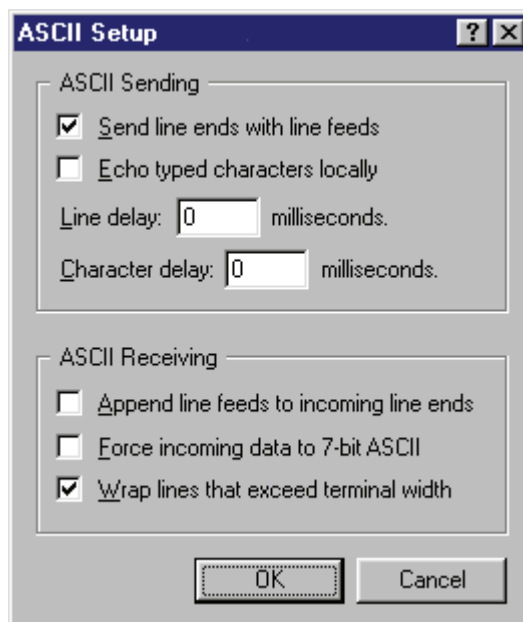
**Figure 11 ASCII Setup Screen under Settings Screen**

You may also consider ASCII Setup parameters to satisfy your display requirements.

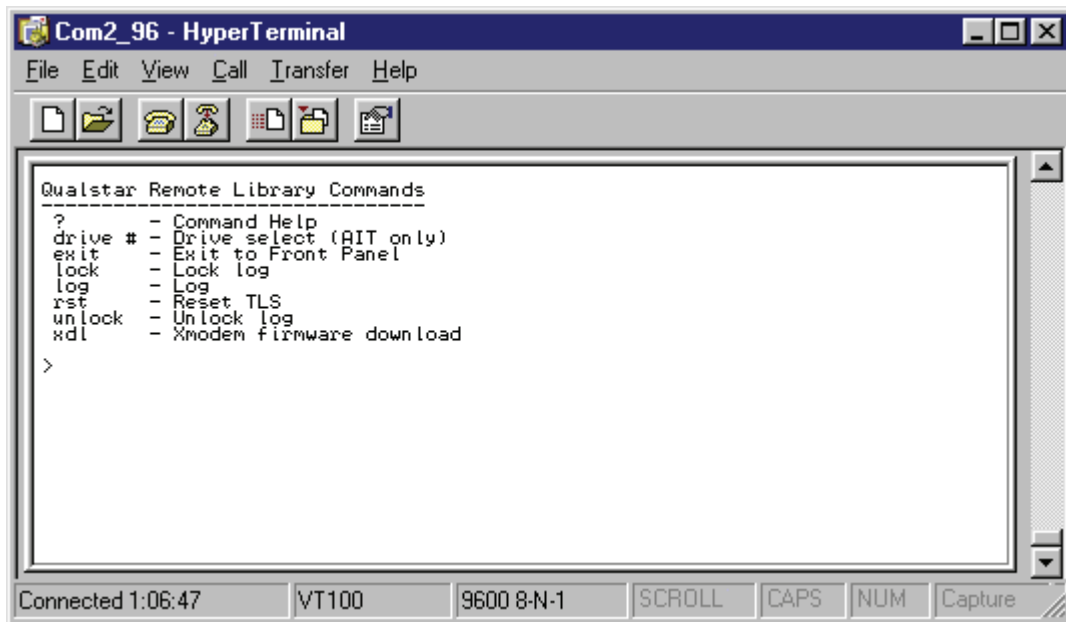
**Figure 12 Remote Library Commands**

To access the Remote Library Command Mode, press the ESC key and type “cmd” followed by the <Enter> key. This will display the Command Help screen depicted in Figure 12 followed by a DOS-like command prompt “>”. Commands may now be entered in lower case text. All commands must end with the <Enter> key. Most terminal emulators support the backspace key for correcting typing errors. Quotation marks are shown for clarity and are not to be typed in the actual command line.

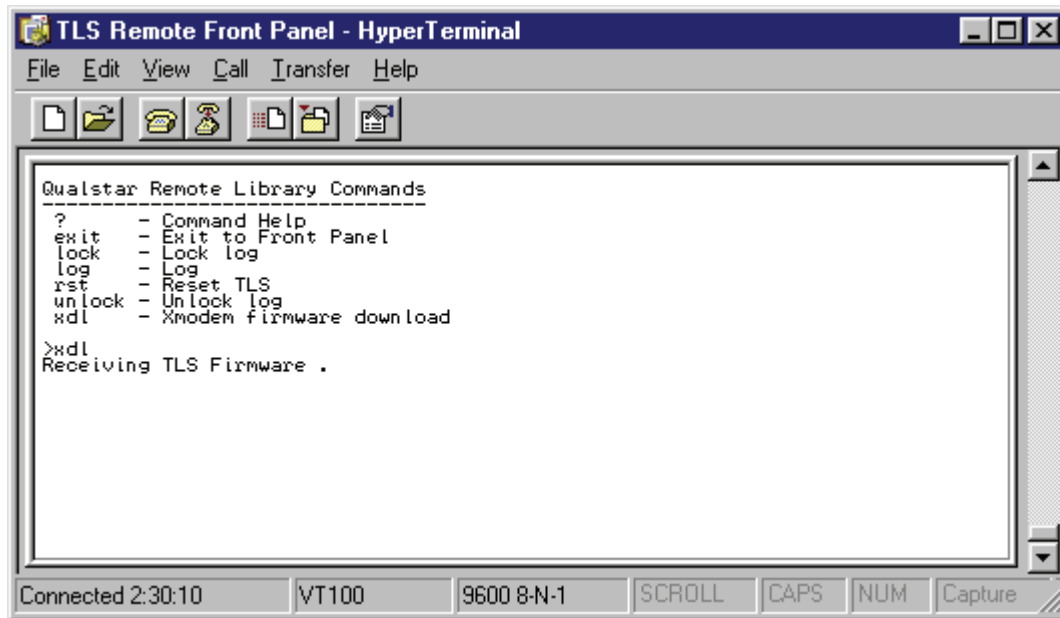
**Figure 13 Example of Xmodem Firmware Download**

Enter the command “xdl”. The application will respond “Receiving TLS Firmware”, to indicate it is waiting for the user’s xmodem data.

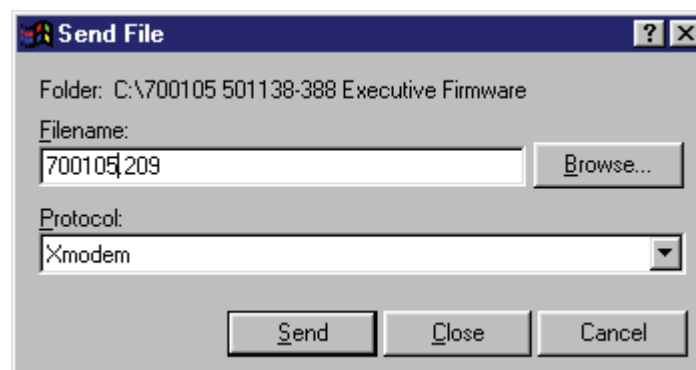
**Figure 14 Send File Screen Under Transfer**

Use the HyperTerminal menu function Transfer->Send File, to download the TLS firmware file to the library. TLS firmware object files are typically named 700105.211 where 700105 represents the code-set name and 211 is the Version (Version 2.11 in this example). A revision letter may follow the code-set name.

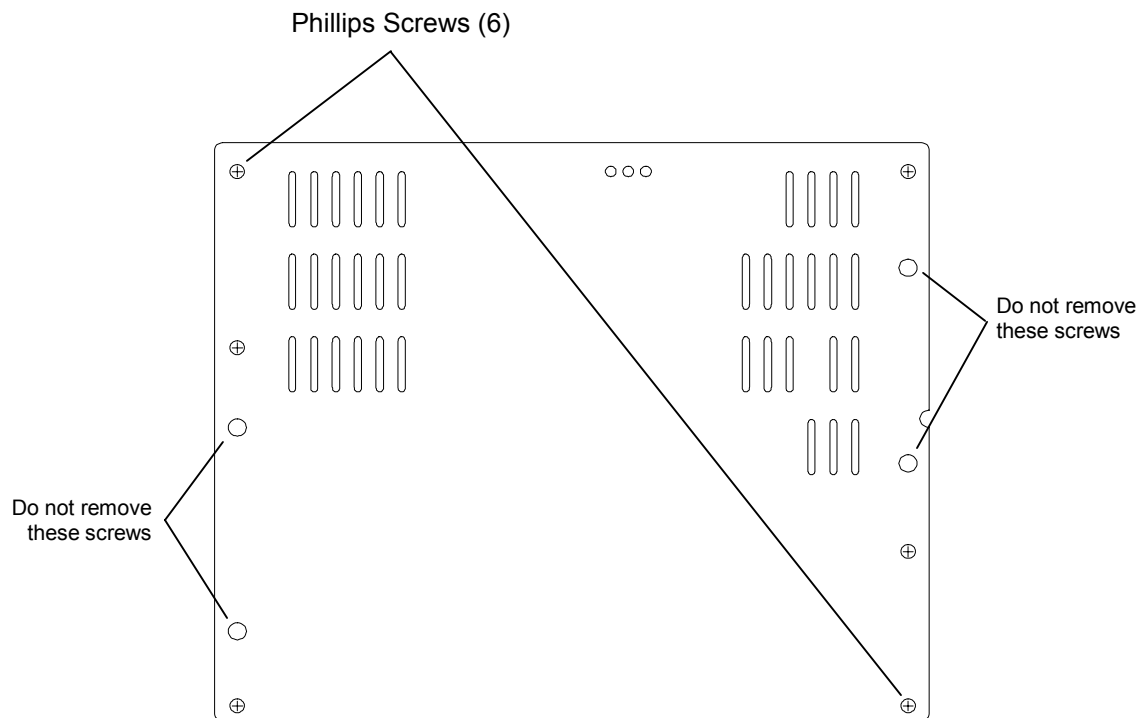
**Figure 15 Rear Service Panel**

1. Remove power from the TLS: first turn the power switch off and then remove the power cord.
2. Remove the six Phillips screws securing the service panel on the rear of the library – refer to Figure 15 below. Care must be taken to not remove the four screws securing the heatsink panels.

1. Remove power from the TLS: first turn the power switch off and then remove the power cord.
2. Remove the six Phillips screws securing the service panel on the rear of the library – refer to Figure 15 or Figure 18 on TLS-412xxx and 68/88xxx models. Care must be taken to not remove the four screws securing the heatsink panels.
3. Remove the Flash-Memory IC at U4 (Part Number is 700105 or 700115) from the Executive PCBA using a thin flat blade screwdriver, pocketknife or equivalent tool. Note the IC location (U-number) is identical on Executive II, III and IV boards. Pry the IC from either end slightly and repeat for the other end. Continue this procedure until the part is loosened enough to be removed by hand. Refer to Figure 17.

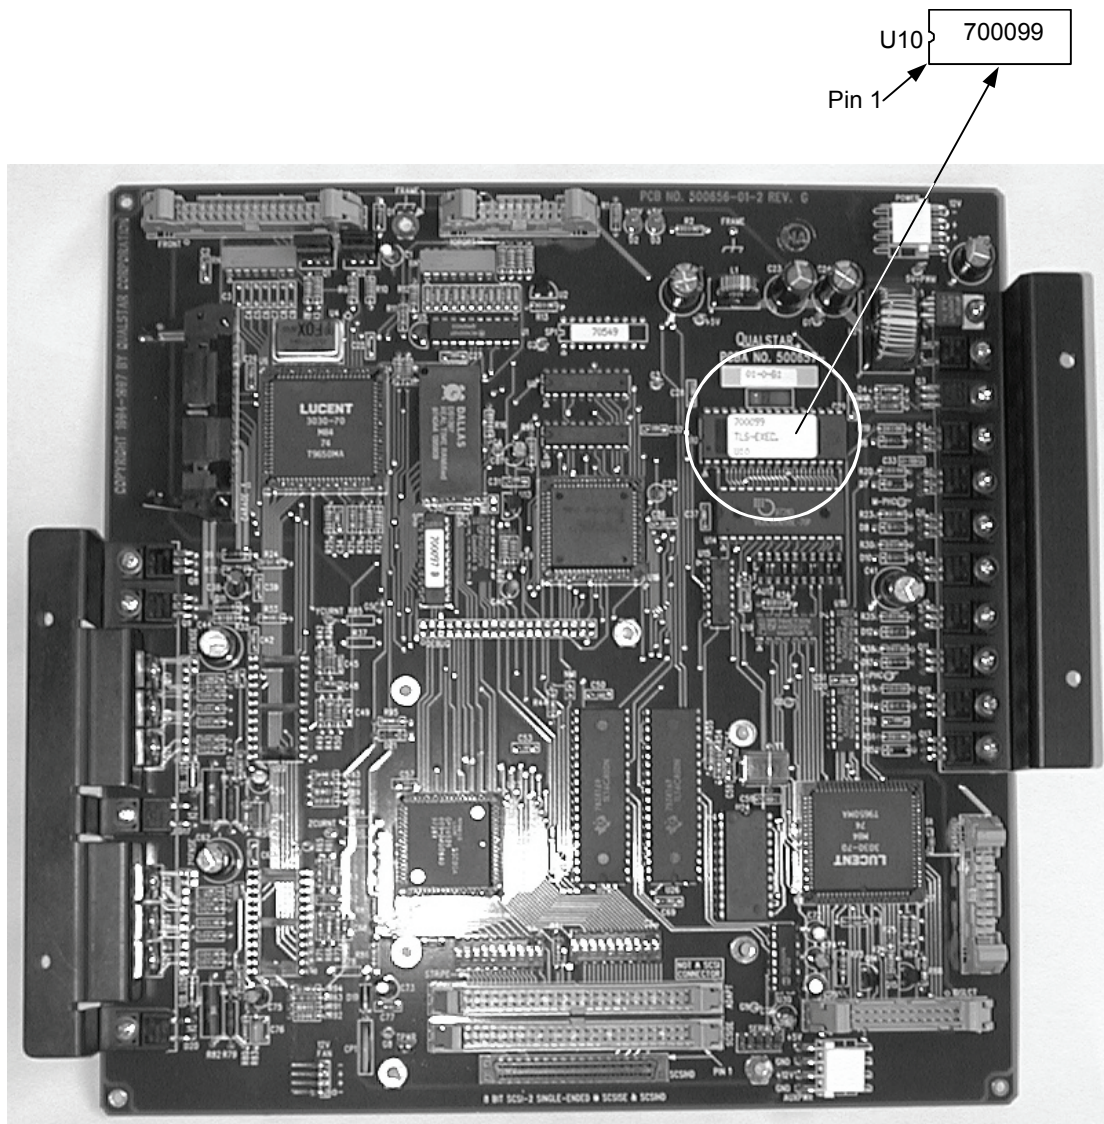
**Figure 16 500657-01-0 Executive I PCBA**

3. Remove the Flash-Memory IC at U10 (Part Number is 700099) from the Executive I PCBA using a thin flat blade screwdriver, pocketknife or equivalent tool. Pry the IC from either end slightly and repeat for the other end. Continue this procedure until the part is loosened enough to be removed by hand. Refer to Figure 16 below.
4. Install the new 700099 Flash-Memory IC at U10. Note the orientation of pin 1. Make certain that all pins are fully inserted into the socket.
5. Replace the rear service panel and secure it with the six Phillips screws.
6. Connect the power cord and switch the power on.
7. Go to the Maintenance\Display Revision menu (see Table 3) and verify the firmware P/N and Revision are correct.

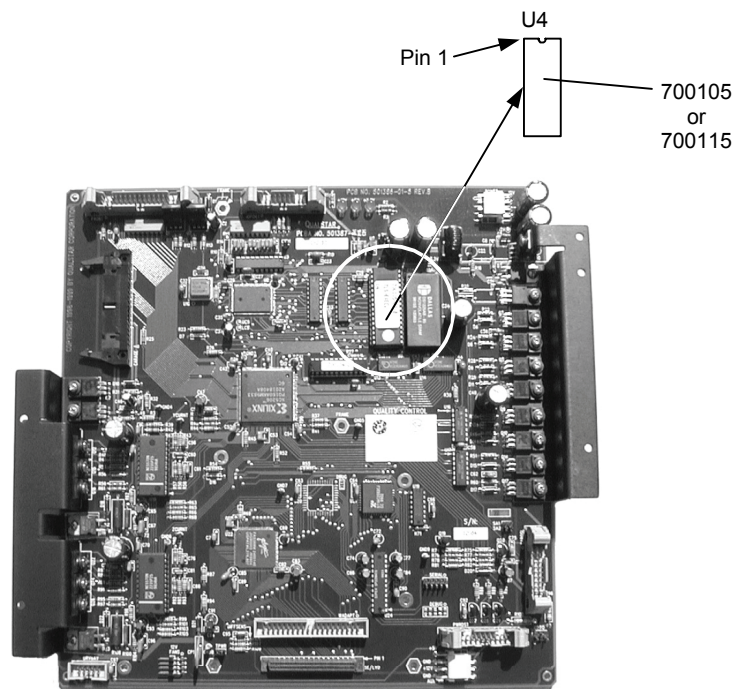
**Figure 17 Executive II, III or IV PCBA**

4. Install the new 700105 or 700115 Flash-Memory IC at U4. Note the orientation of pin 1. Make certain that all pins are fully inserted into the socket.

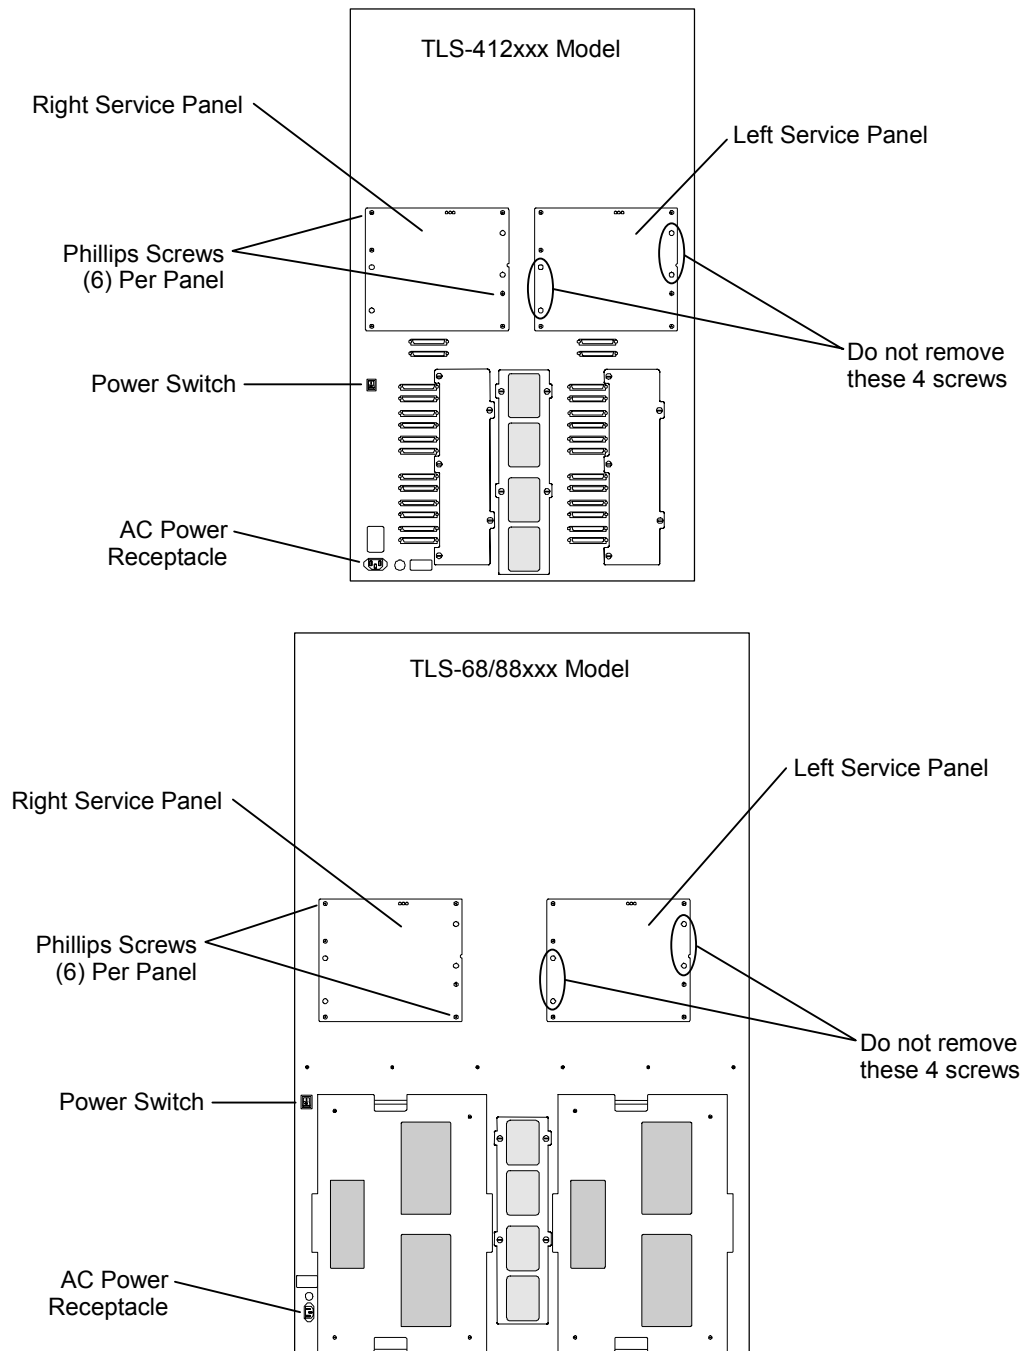
**Figure 18 TLS-412xxx and 68/88xxx Executive Board Access**

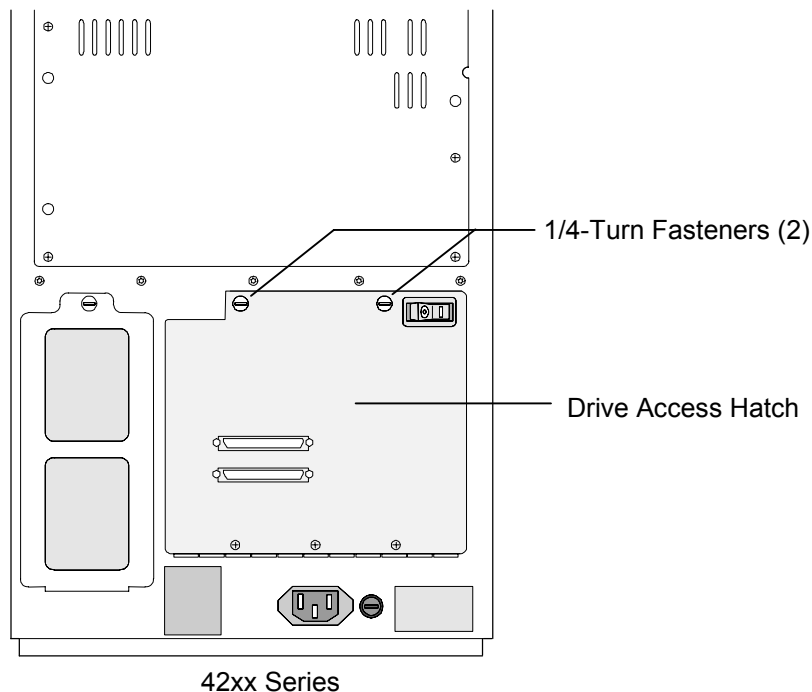
**Figure 19 TLS Rear View (42xx shown)**

1. Remove power from the TLS: first turn the power switch off and then remove the power cord.
2. On TLS-42xx series libraries, open the Drive Access Hatch at the rear of the TLS by turning its two 1/4-turn fasteners one quarter-turn counter-clockwise (see Figure 19). On all other models, remove the Drive Access Panel at the rear of the TLS by turning the three to five 1/4-turn fasteners one quarter-turn counter-clockwise (see Figure 20 or Figure 22).

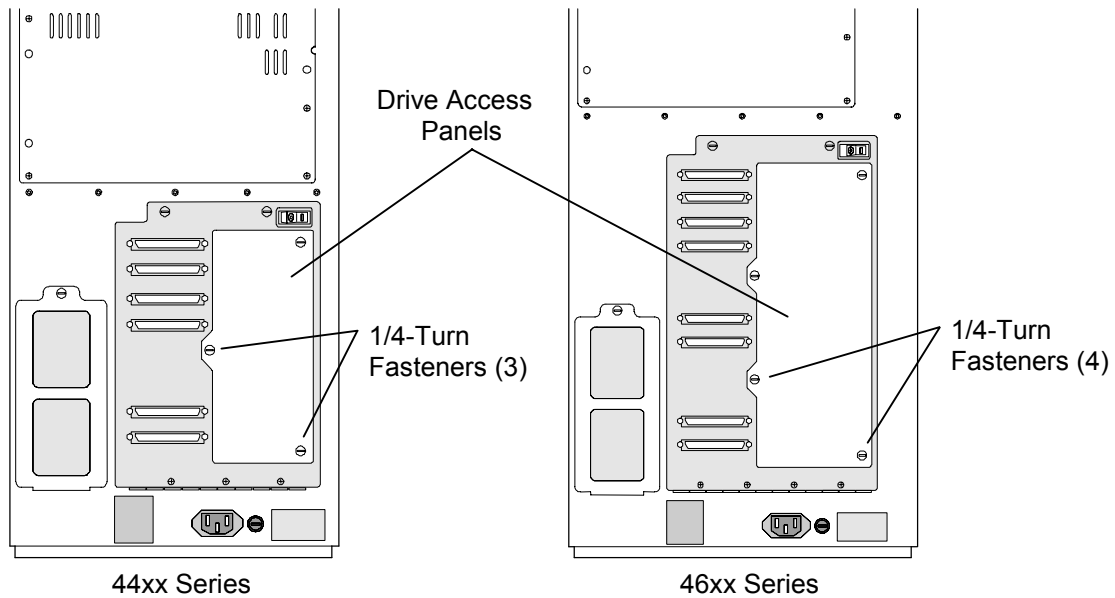
**Figure 20 TLS Rear View (44xx and 46xx shown)**

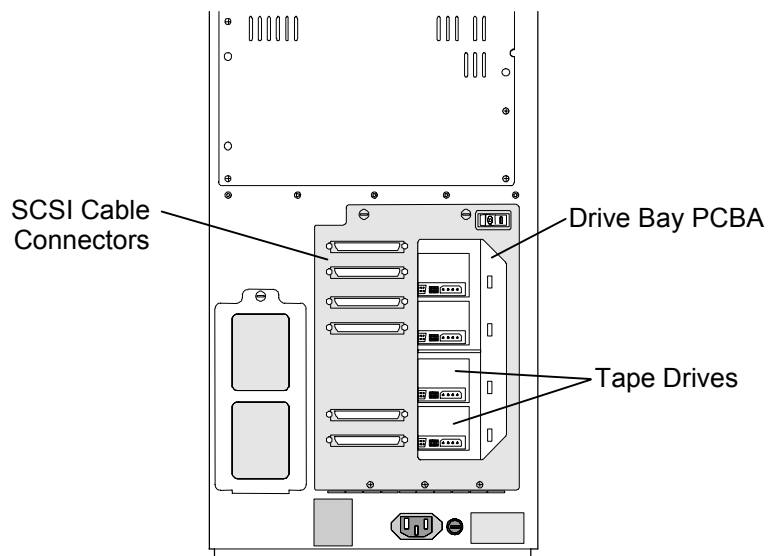
**Figure 21 Drive Bay PCBA (TLS Rear View)**

3. Locate the Drive Bay PCBA (Figure 21 or Figure 23). Remove the Flash-Memory IC from the Drive Bay board (see Figure 24) using a thin flat blade screwdriver, pocketknife or equivalent tool. Pry the IC from either end slightly and repeat for the other end. Continue this procedure until the part is loosened enough to be removed by hand.

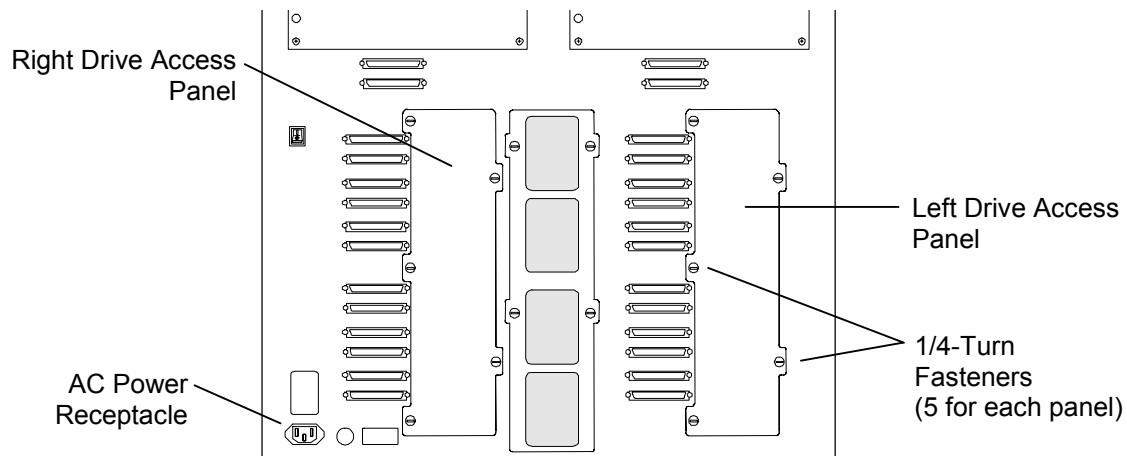
**Figure 22 Access Panels on TLS-412xxx**

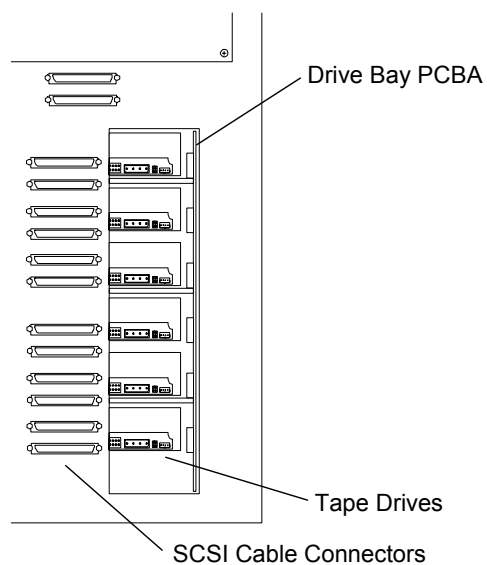
**Figure 23 Drive Bay Board on TLS-412xxx (Rear View)**

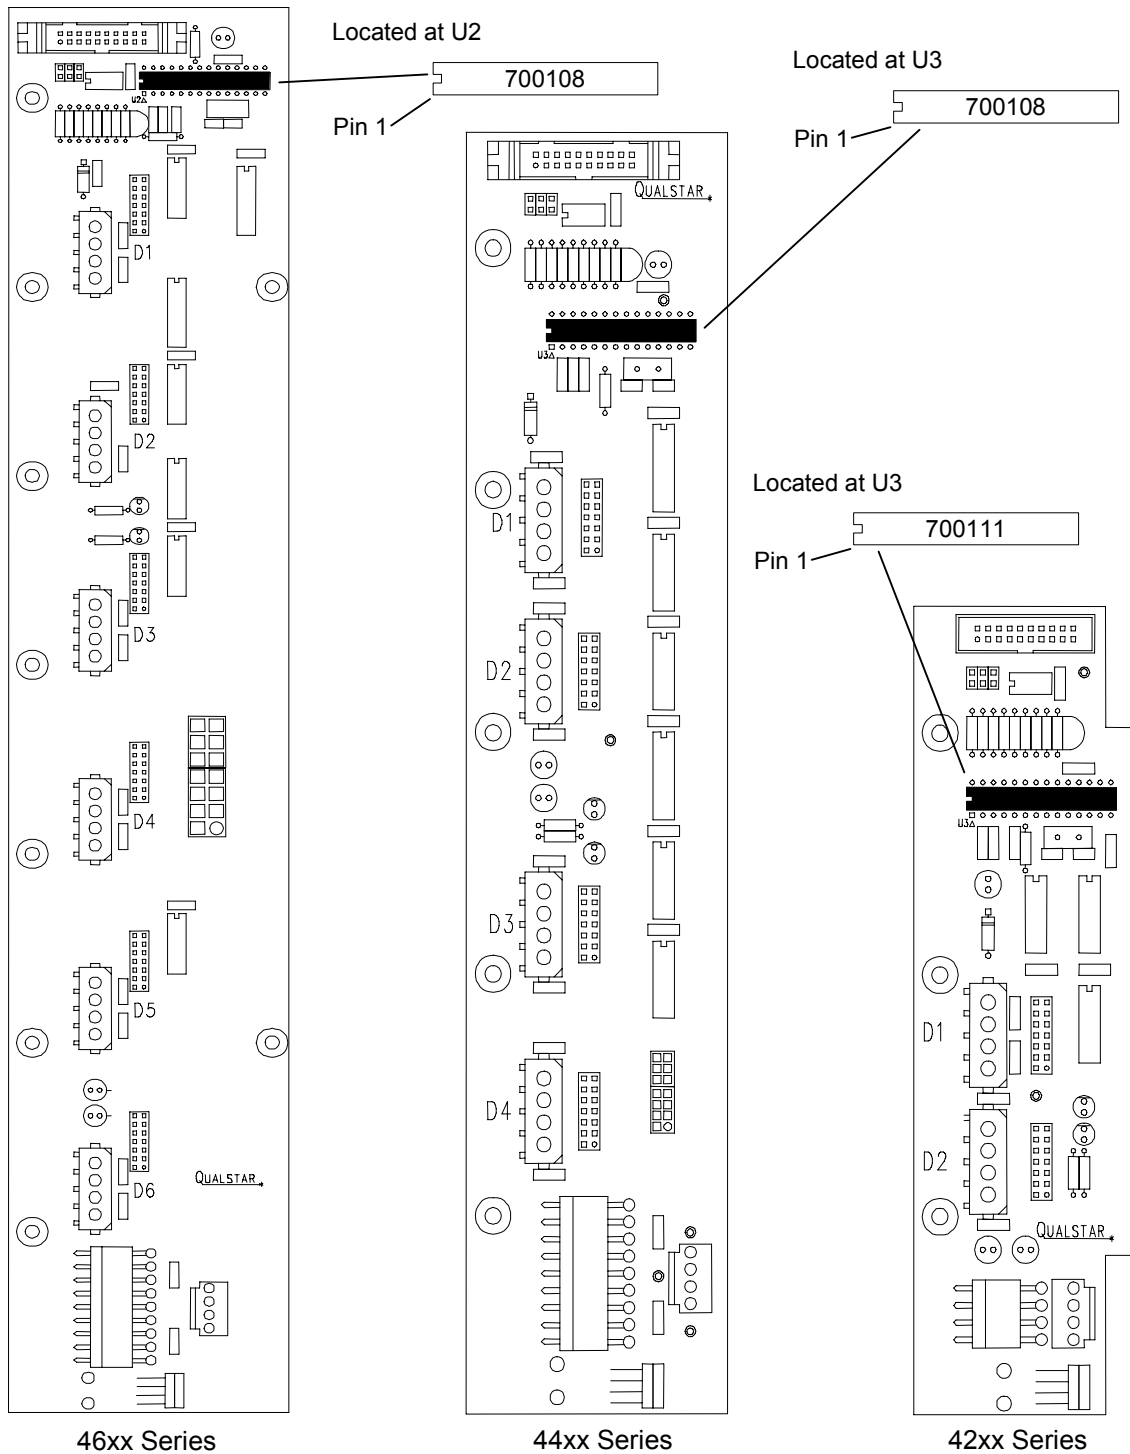
**Figure 24 Drive Bay Boards: 6X, 4X, 2X**

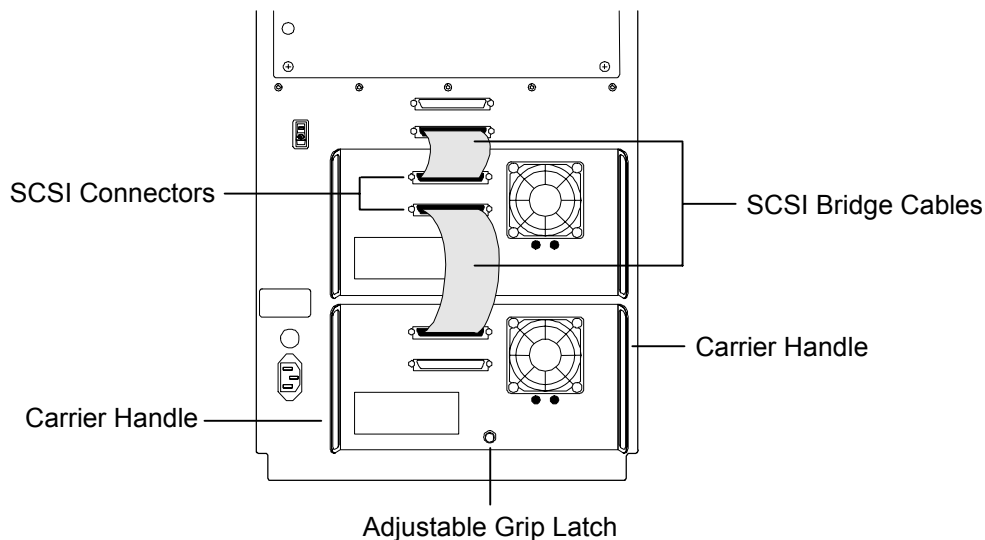
**Figure 25 Tape Drive Assembly (Rear View)**

1. Remove power from the TLS: first turn the power switch off and then remove the power cord.
2. Detach both SCSI cables (or SCSI cable and terminator) attached to the rear of the assembly (see Figure 25).

11. To reinstall the tape drive assembly in the TLS, hold the assembly right side up, place it on the Mounting Rails between the Guide Pins, then gently slide it all the way into the TLS. Refer to Figure 28.
12. Turn the adjustable grip latch on the tape drive assembly all the way clockwise by hand, until it is finger-tight. Refer to Figure 25. Do not over-tighten.
13. Pull on the tape drive assembly's carrier handles to make sure that the tape drive assembly is locked in place. Refer to Figure 25.
14. Reconnect both SCSI cables or cable and terminator.

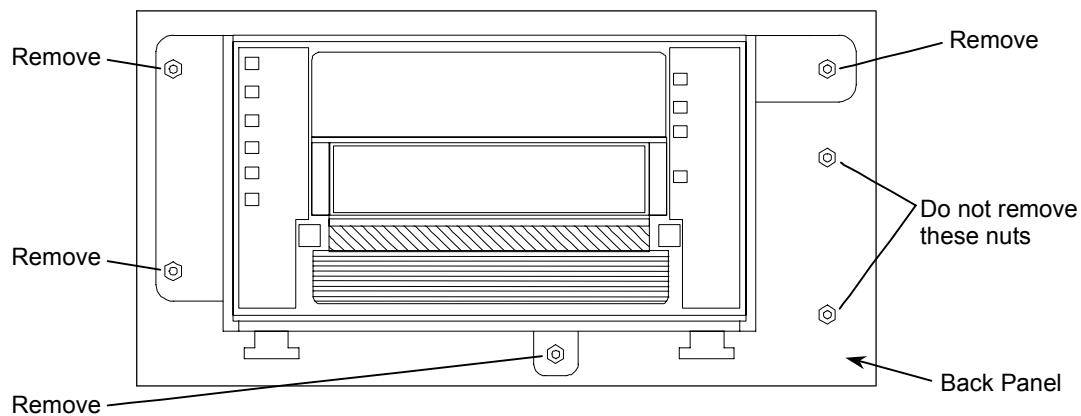
**Figure 26 Tape Drive Assembly (Front View)**

5. Carefully stand the tape drive assembly on its Carrier Handles and remove the four 1/4-inch locking nuts that secure the back panel. Do not remove the two locking nuts securing the circuit board. Refer to Figure 26.

10. Replace the back panel on the tape drive assembly that was removed in Figure 26 and retighten the four 1/4-inch locking nuts securely.

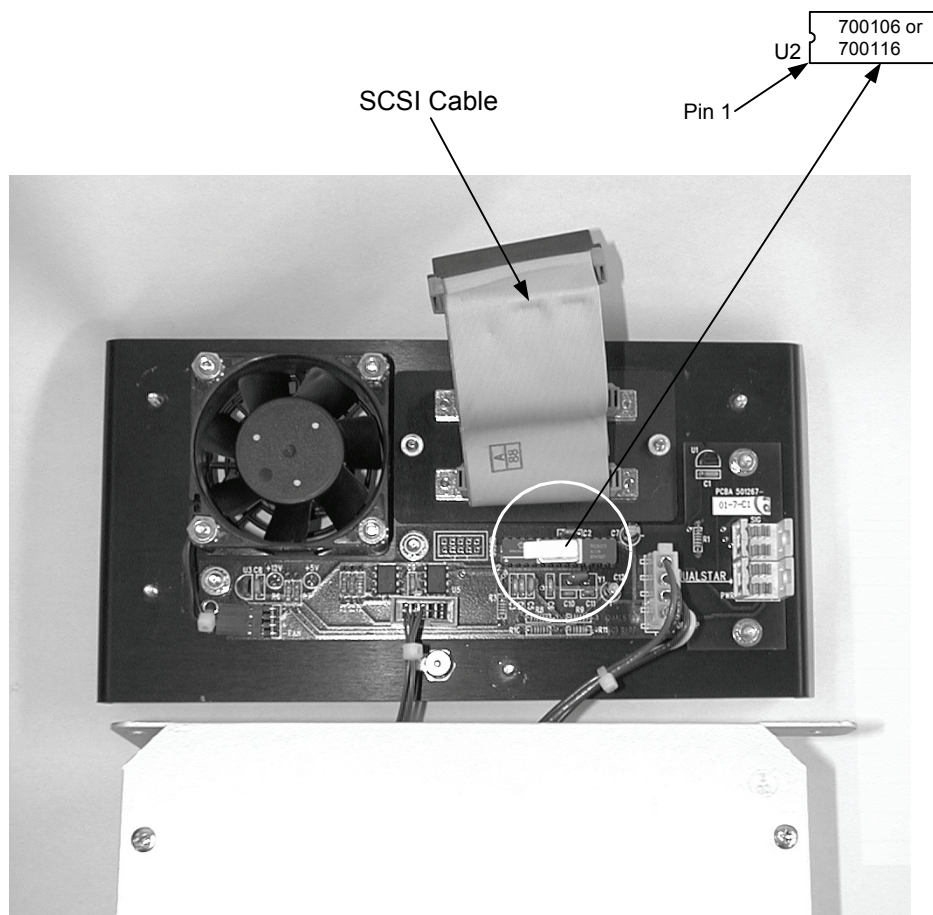
**Figure 27 Drive Carrier PCBA**

6. Gently remove the back panel using caution to not damage the wiring. Disconnect the SCSI cable from the tape drive to allow access to the Drive Carrier PCBA. Refer to Figure 27 below.

7. Remove the Micro-controller IC at U2 (P/N 700106 or 700116) from the Drive Carrier board using a thin flat blade screwdriver, pocketknife or equivalent tool. Pry the IC from either end slightly and repeat for the other end. Continue this procedure until the part is loosened enough to be removed by hand. Refer to Figure 27 below.

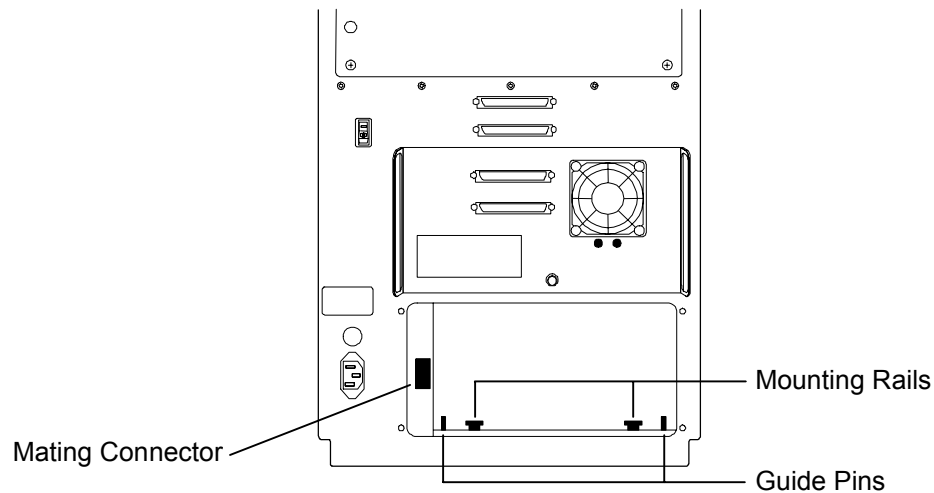
**Figure 28 Tape Drive Assembly-Mounting Rails/Guide Pins**
